**Strathclyde Fire Brigade**

**Petershill Court**

**17<sup>th</sup> November 2004**

**Briefing Note**

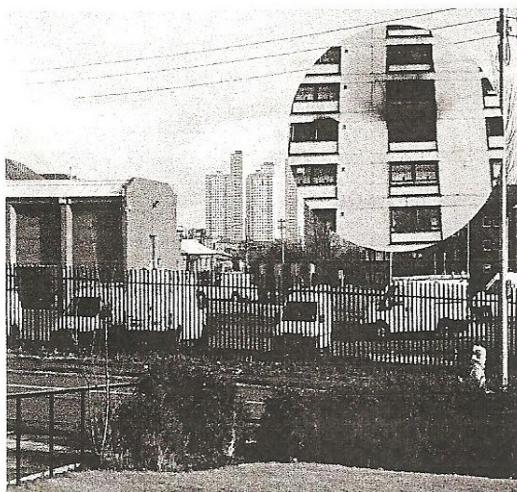
**Figure 1** – View from Springburn Fire Station as seen by crews attending 30 Petershill Court on 17<sup>th</sup> November 2003.

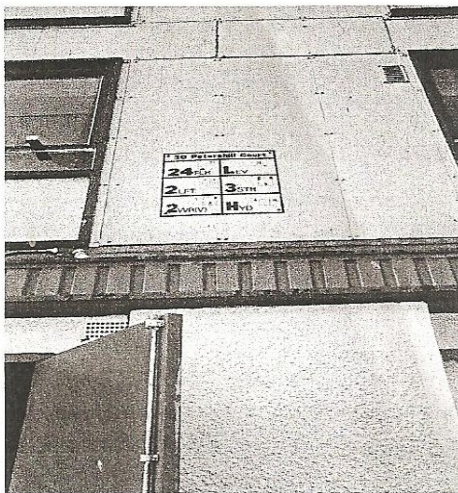
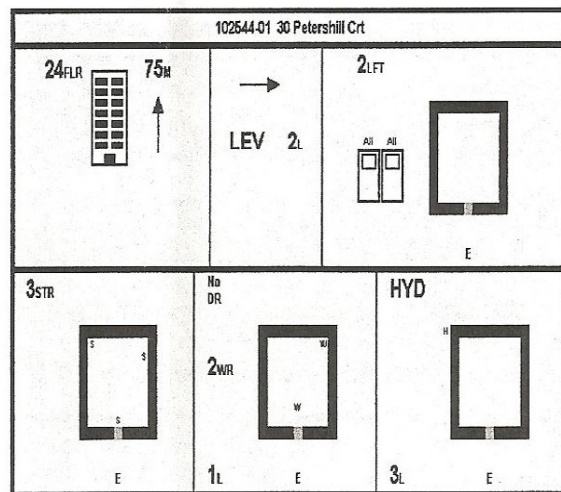
Figures 2 & 3 demonstrates the guidance plate available at 30 Petershill Court. This information is available on all residential high rise premises in Strathclyde and provides the OIC with valuable operational intelligence regarding construction, water supplies and access.

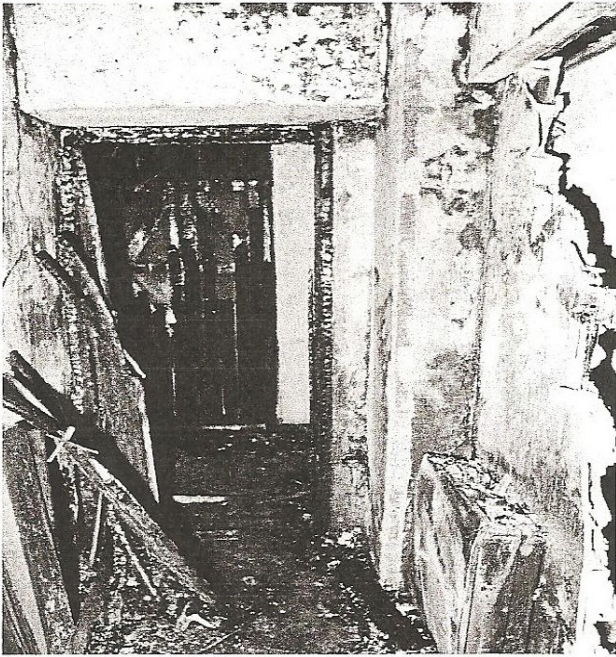
**Figure 4** presents a view of the fire scene and indicates the degree of involvement.

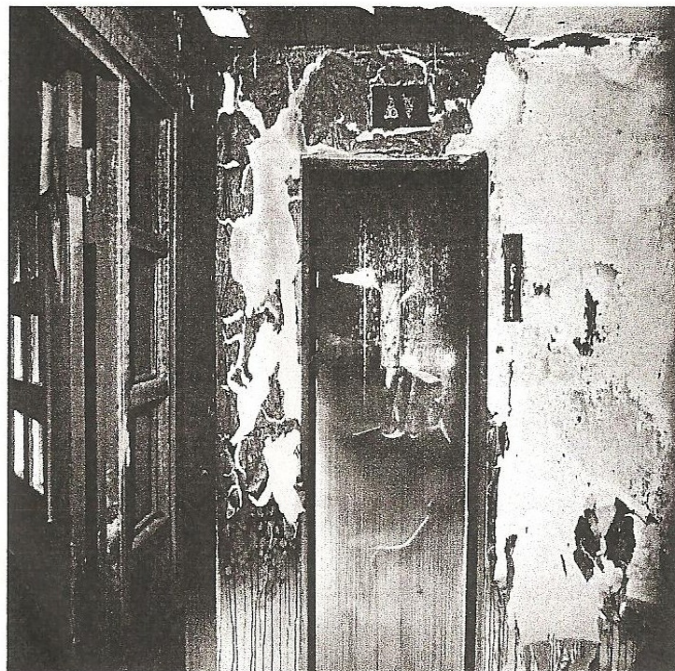
**Figure 5** indicates the level of damage to the 21<sup>st</sup> floor lift doors. Note that the lifts open directly into the lobby and are not separated from the four dwellings on this level.

The door visible in the left of this picture opens directly onto the stairway. This serves all floors and has no separation. This led to smoke logging down to the 7<sup>th</sup> floor.

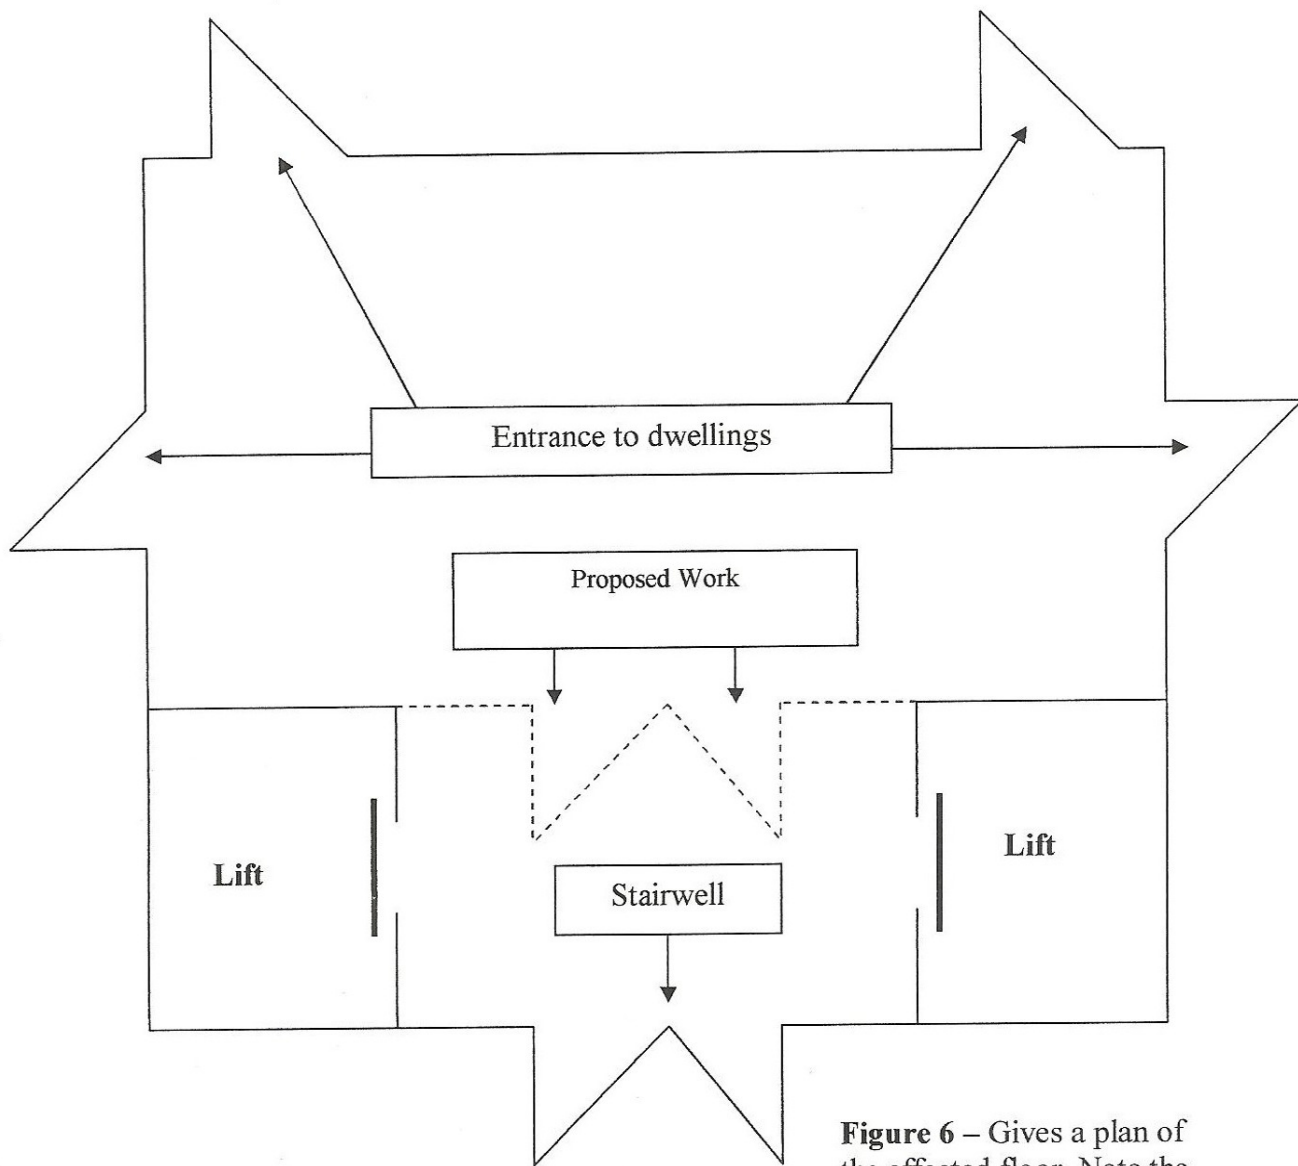
**Figure 6** – Gives a plan of the affected floor. Note the Brigade’s proposal (annotated in red) to have the lifts separated from the dwellings, thus creating a protected lobby.
